els extra low shrinkage®

Clinical case study by Christoph Pröbstl

Photographic series of the clinical case study using els extra low shrinkage®

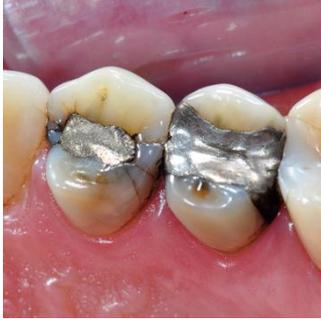
Initial situation

On initial observation the very old fillings were very noticeable, though examination did not indicate any sign of a filling defect or secondary caries. The patient reacted positively to the sensitivity test on teeth 14 and 15, but more intensively with tooth 14.

On closer examination mesial and distal fracture lines were detected with tooth 14 and, based on the discoloration, it was assumed that they had already existed a long time. Individual enamel sections of the mesial wall could be slightly moved with forced probing in the mesial region of tooth 14. This was due to the mercuroscopic expansion of the amalgam fillings, which were now at least 35 years old. Owing to the long period in situ of the filling the expansion pressure of the filling caused a fracture of the mesial wall and the masticatory pressure led to loosening of the enamel sections from the bond of the enamel wall.

35-year-old insufficient amalgam restorations teeth 14, 15

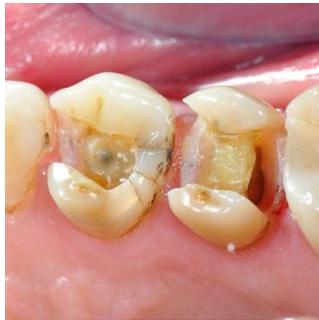
Preparation

Excavation and finishing preparation margins, rubber dam

After minimally invasive removal of the existing fillings of both teeth and excavation of slight secondary caries in the distal region of tooth 15, the enamel margins were smoothed and clearly defined, proximal shoulders prepared. The shade was also selected at this time. The interfering influences of the amalgam on the shade were eliminated and the shade of the dentine was clearly recognisable. In this case we decided for shade A3.

A rubber dam was placed as filling treatment using composite, if possible, always requires complete isolation. Sectional matrices were placed mesially and distally on tooth 15.

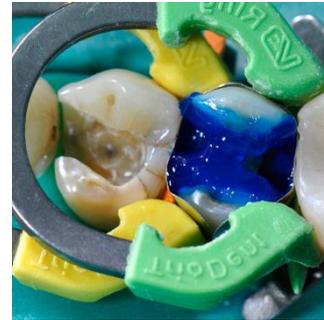
Etching using cmf etch

Prepared cavity with sectional matrices and separating rings, total etching

Wooden wedges and separating rings were placed to secure the sectional matrices in position and separate the teeth to achieve a good proximal contact point.

After checking the correct fit of the sectional matrices, etching was completed as the first working stage using cmf etching gel from Saremco. As total etching was used cmf etching gel was particularly suitable in this case due to its increased pH value. This protected the dentine and enamel. As a result possible problems of postoperative sensitivity were reduced. After rinsing off the etching gel, care was taken to ensure that the cavity was kept slightly moist to prevent collapse of the dentine collagen fibres.

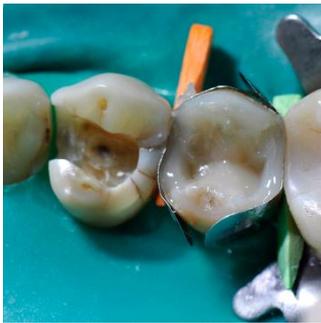
Build-up using els extra low shrinkage®

Reconstruction in several layers (els consistency-optimised) shade A3

As the cavity was now correctly prepared the mesial and distal sections of the cavity walls could be filled using the new, consistency-optimised els. It was an advantage when filling the sections that the consistency-optimised els does not flow very quickly initially and has a better dimensional stability. Consequently it was easier to build up both proximal walls in one working stage. Care was taken to place

the mesial and distal marginal ridge at the same height as the adjacent teeth.

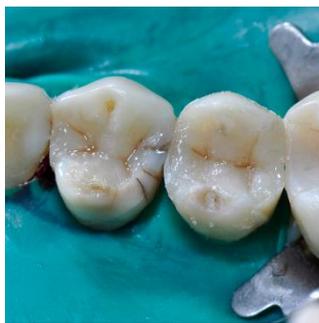
Finished build-up before finishing. Fissures with SAREMCO paintart brown

After light curing and reconstruction of the outer tooth contour, the separating rings were removed to facilitate access to the cavity. This made it easier to sculpt the occlusal surface.

At the first stage the central cusp slopes were contoured and cured from the palatal and buccal towards the central fissure. Composite was then applied in the mesial and distal section of the cavity and carefully sculpted to reconstruct the surface of the premolar as anatomically correctly as possible. Saremco brown stain was placed in the central fissure for special effect.

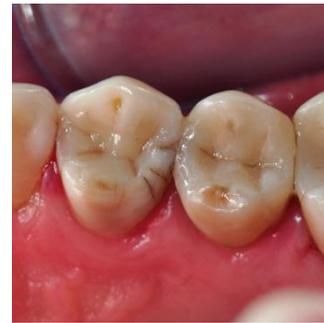
Final result

Anatomically correctly contoured filling after finishing and polishing

Rough excess was removed using finishing diamonds, Soflex discs and special tungsten carbide finishers from Komet (Brasseler). The fillings were polished using rubber polishers, also from Komet, and polished to a high-lustre using occlubrushes from Kerr Hawe.
